**Flood Control Project Maintenance
Levee Inspections**

Maintenance Issue Types Only, Levee Inspection Report By Mile - Spring 2019

City of Sacramento

Waterway	Bank	Unit Miles	Inspection Start/End	Inspector
Unit No. 01 Sacramento River	Left	3.67	04/17/2019 04/17/2019	Luz Dial

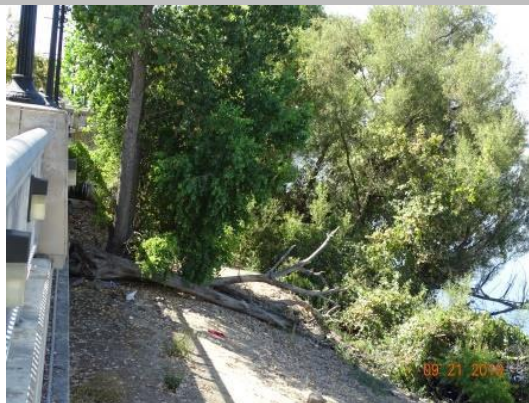
Photo 1 of 1 : SP_2019_NA0005_251_83_20190307_00008.jpg

LM Start	0.84	Rating **	A/W	Issue No.	83
LM End	0.84	Issue Type +	Ma	Location *	WS
Category	Earthen Levee			GPS Latitude/Longitude	
				Start	End
Item	Encroachments			38.578955 °	38.578955 °
				-121.507703 °	-121.507703 °
DWR ID	DWR_NA0005_01_f_2018_83				
Comment Code					
TR : Tree or limb					
Inspector Comment					
Removal of log next to floodwall could not be verified due to high water.

Tree debris against floodwall. Fall 2018

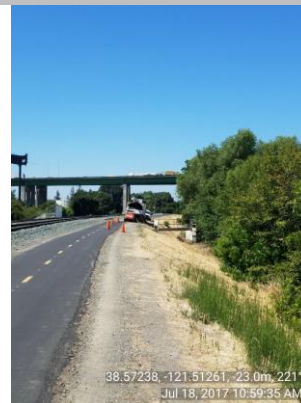
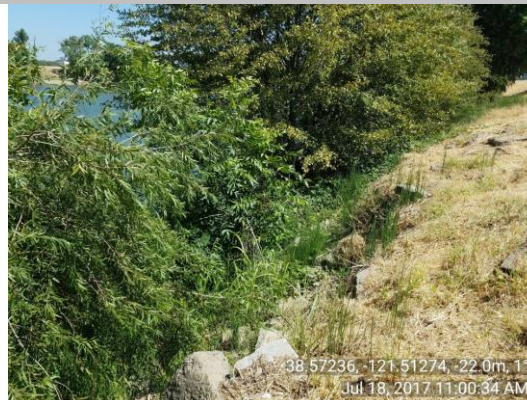
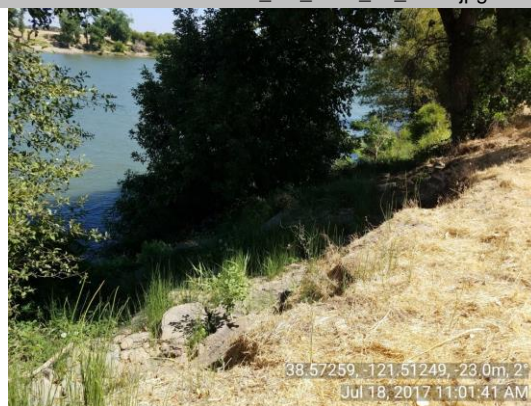
LM Start	1.46	Rating **	A/W	Issue No.	91	
LM End	1.46	Issue Type +	Ma	Location *		
Category	Supplemental			GPS Latitude/Longitude		
				Start	End	
Item	2017 Storm Damage			38.571397 °	38.571397 °	
				-121.513797 °	-121.513797 °	
DWR ID	DWR_NA0005_01_f_2017_75					
Comment Code						
Inspector Comment						
Levee Evaluation Comments						
Description:						
Site ID No:50						
Site Designation:SCDU-03						
Repair Type: Erosion						
Rating:Critical						
Field Date:7/18/2017						
Notes:

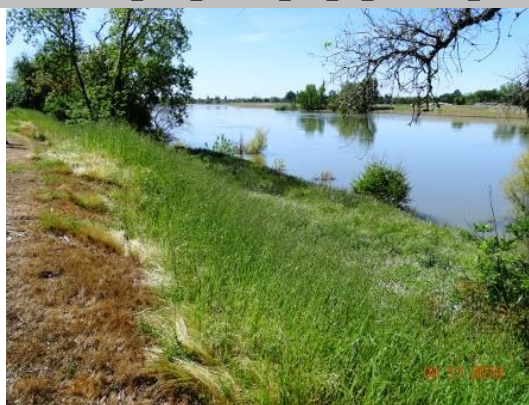
Photo 1 of 1 : SP_2019_NA0005_251_87_20190418_00108.jpg

LM Start	1.99	Rating **	M	Issue No.	87
LM End	3.67	Issue Type +	Ma	Location *	WS
Category	Earthen Levee			GPS Latitude/Longitude	
				Start	End
Item	Vegetation			38.564443 °	38.541075 °
				-121.516140 °	-121.511413 °
DWR ID	DWR_NA0005_01_s _ 2019_87				
Comment Code					
V1 : Control annual grass and weeds on the levee slopes and easements.					
Inspector Comment

View looking downstream at tall waterside vegetation. Spring 2019

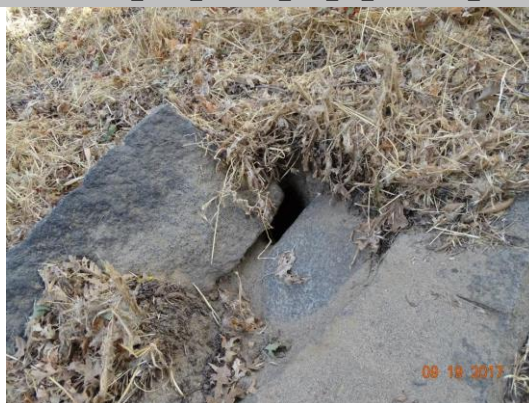
Photo 1 of 1 : SP_2019_NA0005_251_82_20190307_00007.jpg

LM Start	2.31	Rating **	A/W	Issue No.	82
LM End	2.31	Issue Type +	Ma	Location *	WS
Category	Earthen Levee			GPS Latitude/Longitude	
				Start	End
Item	Animal Control			38.559767 °	38.559767 °
				-121.515264 °	-121.515264 °
DWR ID	DWR_NA0005_01_s _ 2016_82				
Comment Code					
A3 : No rodents visible, but rodent burrows visible; need to backfill and compact or grout burrows.					
Inspector Comment					
No animal holes were visible during this inspection due to vegetation.

View of rodent hole on waterside slope. Fall 2017.
